Background

Project Details

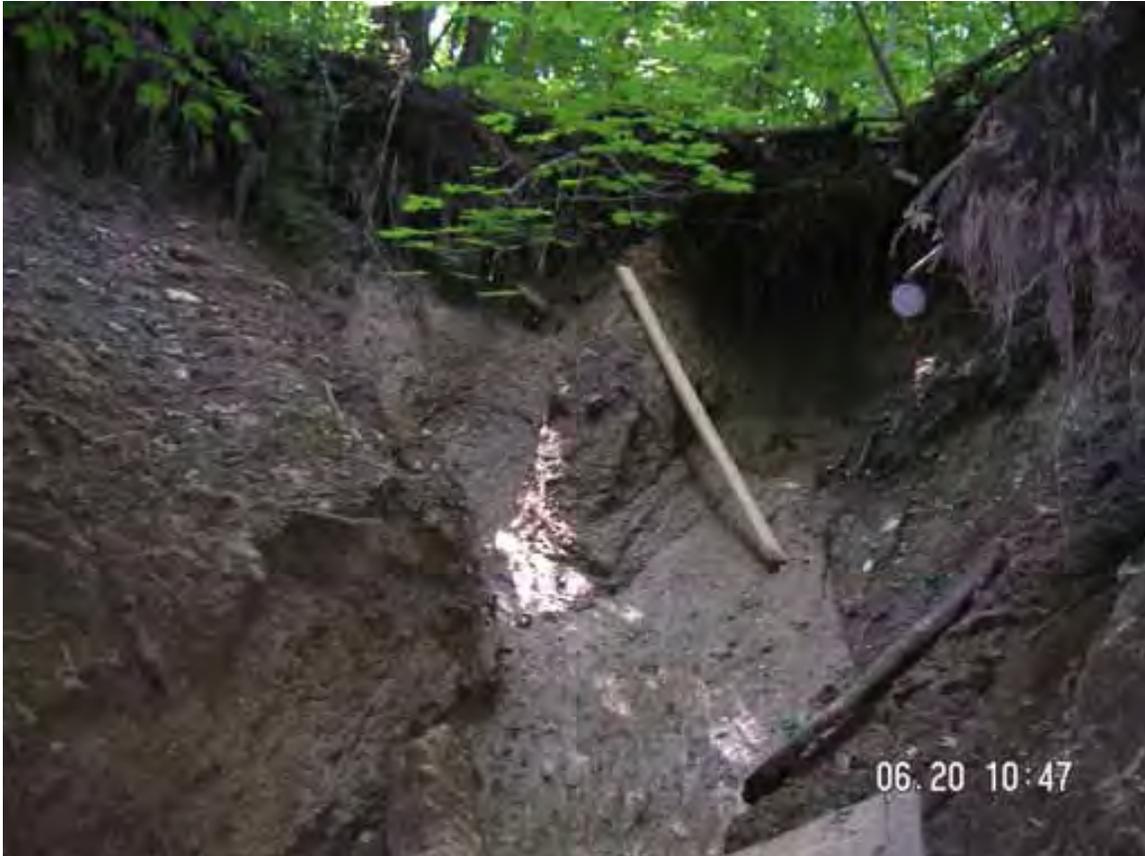
In the summer of 2005 a heavy rain storm caused a 15 cubic yard section of an unstable ravine West of Cyrus Trail and 300 yards north of 130th Street to slough off an undercut bank and wash down the ravine. Figure 1 shows the size of the most recent erosion area, a small canyon formed by the collapse of the banks in one branch at the head of the ravine. The 8 foot long 2x4 in the picture illustrates the size of the area and the volume of material that has been washed into the lake.

Figure 1. - A lead forming at the head of the ravine.

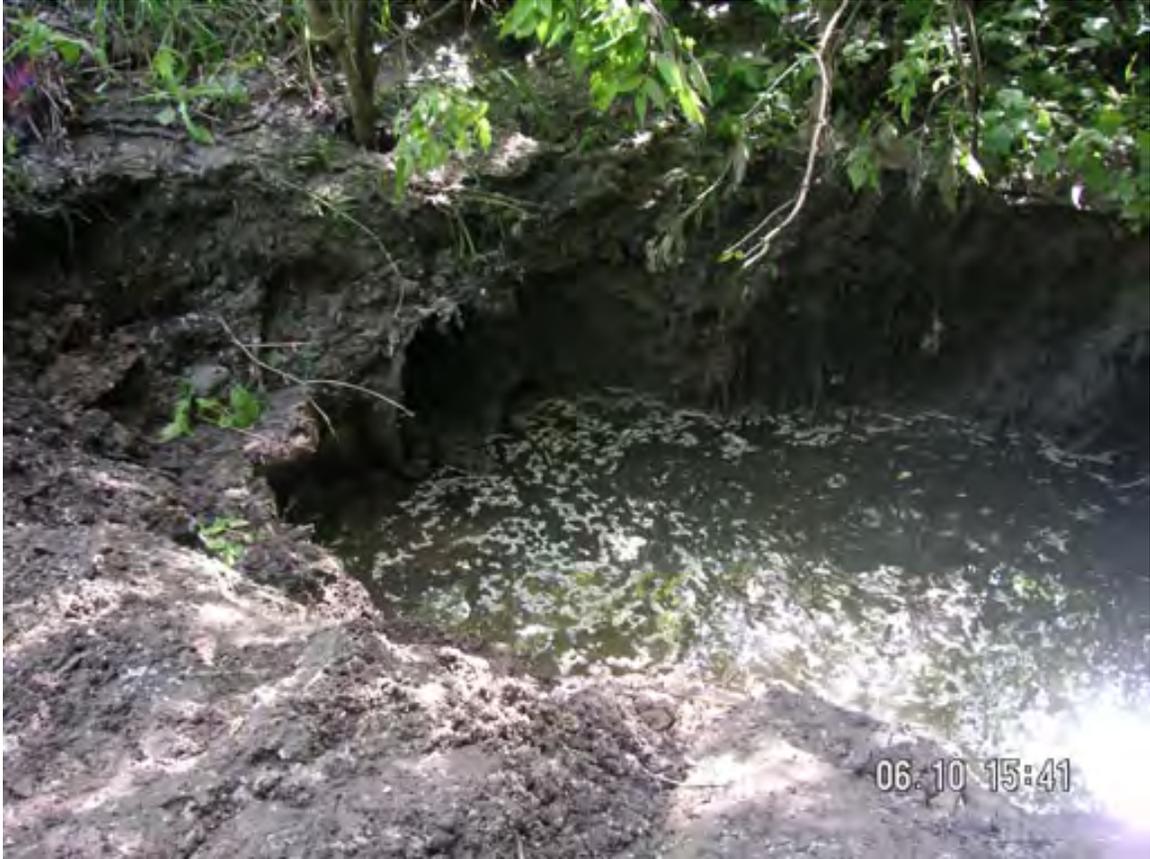
The large slug of soil-water slurry plugged a 24" culvert which carried the ravine water under a driveway en route to the Cyrus Trail road ditch, which leads to the Wolf Creek inlet to the lake. The slurry buried the driveway culvert, overtopped the banks of the ravine and washed across the road. Figure 2 shows the inlet to the culvert after a backhoe was used to clear it of silt.

Figure 2. - The driveway culvert inlet, buried in silt.

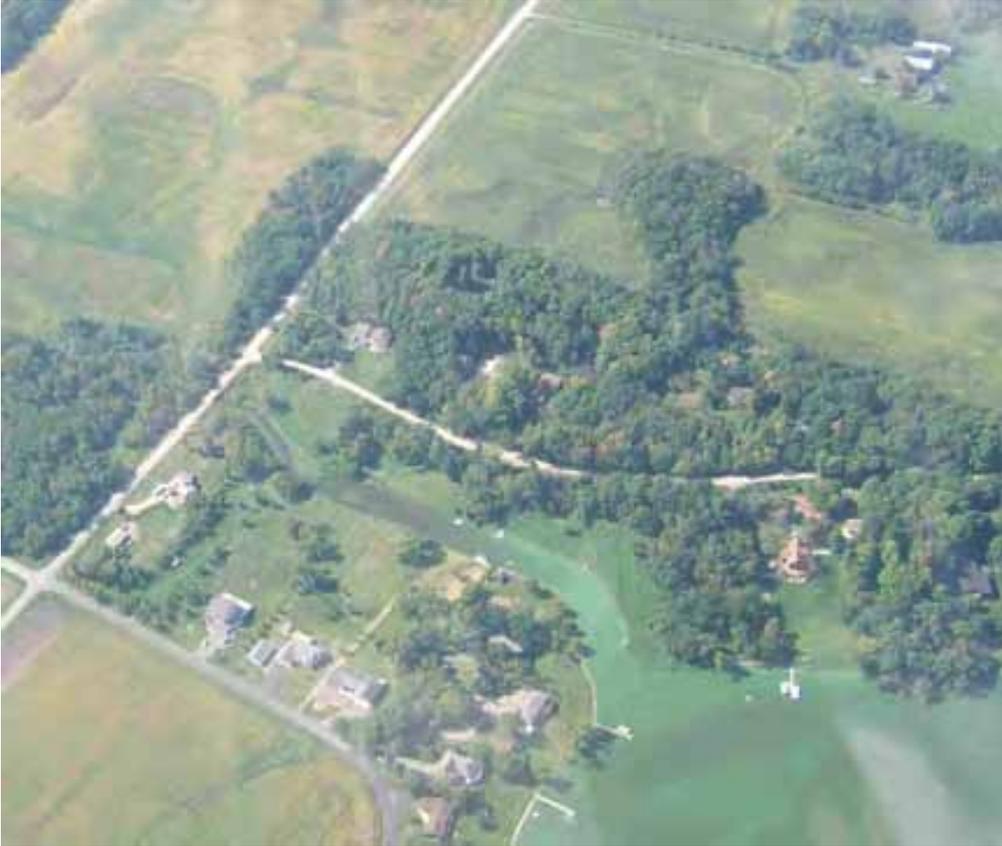
The results of the survey showed the owners' primary concern was the lake's high fertility, causing severe algae blooms. Figure 3 shows an aerial view of the Wolf Creek Inlet during the summer. Note the color of the algae in the water, which is greener than the surrounding farm fields.

Figure 3. - Aerial view of Wolf Creek Inlet.

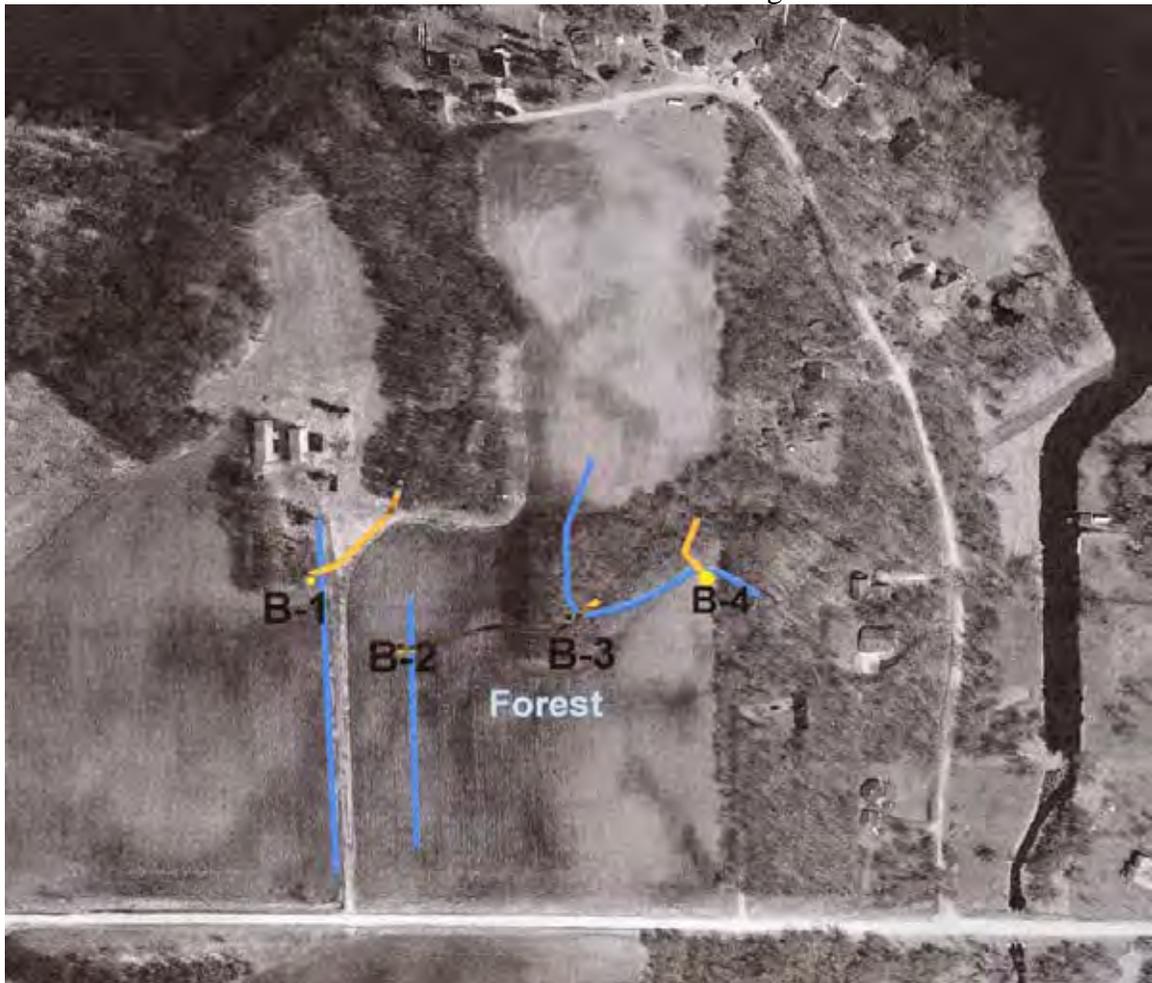
The purpose of the project was to stop the erosion of topsoil from within a steep ravine a few hundred feet north of 130th Street and west of Cyrus Trail, a private road paralleling the Wolf Creek inlet on the south end of the lake. During the spring thaws and every heavy rain event for at least the last 15 years, water flowing east off the farm fields west of the ravine would run over the edges of numerous sharp, un-vegetated, unstable ravine banks, undercutting and tearing out the banks and washing the soil down through the ravine and into the inlet. As explained above, the soil contains phosphorus, which fosters the growth of algae and lake weeds. The solution to the problem was to construct a drainage system that would carry the water from the fields down to the lake via alternative routes and stop the water from washing over the ravine banks. The excavation contractor hired to install the system per the design, first constructed a series of four drainage basins at strategic locations in the fields, designed to collect and temporarily hold the water which used to flow toward the ravine. See figure 4.

Figure 4. – Drainage Project Map.

At the bottom of each of these basins, there is an orange perforated standpipe and drain installed, (shown as a yellow dot in the figure) which is connected to a polyethylene drainage tile. The tiles are buried underground and routed to outlets at the bottom of the ravine. The paths of the tiles are shown as orange lines in the figure. There is a constrictor plate installed under each standpipe, at the inlet to each drain tile. The diameter of the constrictor plate hole is calculated to restrict the water flow in such a way that the water volume collected in a 10 year rain event (4.3 in./24 hours lasting for 36 hours) will not breach the top of the basin's ridge or berm, but will instead be held in the basin and will drain out over a 35 hour period. In NRCS design parlance, this is called the "dewatering time".. The drain tiles each terminate at the bottom of one of two ravines. Basins 2, 3 and 4 are outlet into the Cyrus Trail Ravine, carrying the water east to the lake. Basin 1 outlets into another, stable ravine which flows north into the lake. So now a portion of the water which used to drain from the fields into the Cyrus Trail ravine is diverted to the stable north ravine. In addition to the buried drain tiles, each basin also has a perforated drain tile buried under its high-side berm (shown as blue lines in Figure 4); to prevent water from infiltrating the compacted soil and to drain it away before it can saturate the soil and cause the berms to leak. The photos in figures 5 through 12 show each basin from various directions and distances.

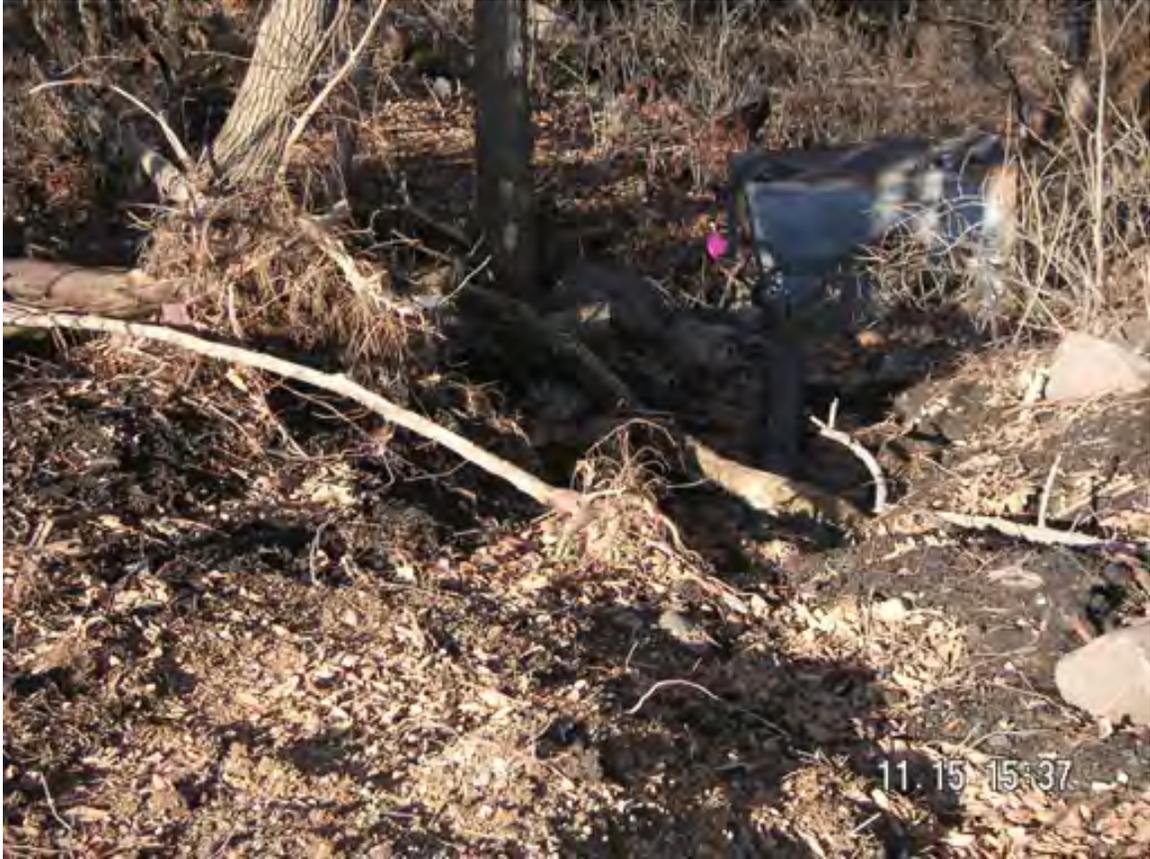
Figure 13. - Basin 1 Outlet, Looking North

Figures 13 through 15 show the basins' outlets into their respective ravines as described above.

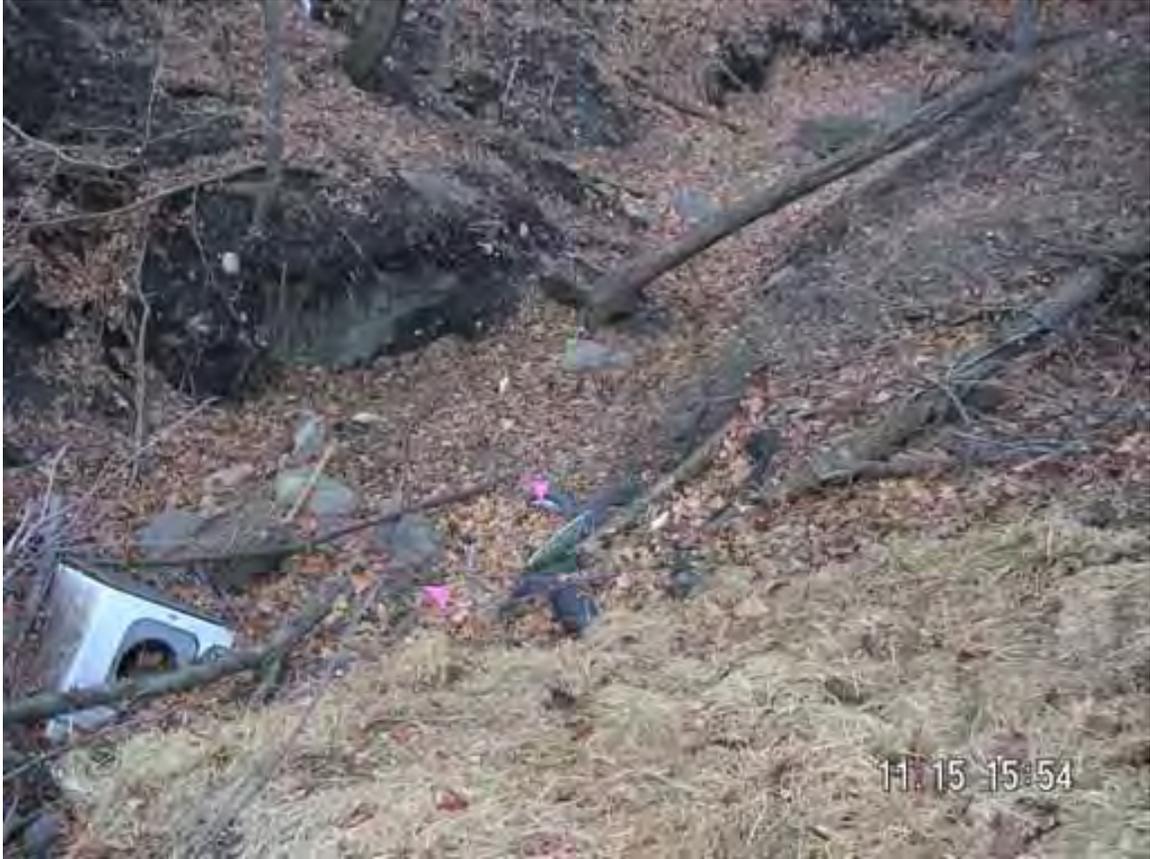
Figure 15. - Basin 4 Outlet, Looking Northeast

The berms forming the high-side containment wall of each basin have been seeded with native grasses to protect them from erosion. The bottoms of the basins will contain the crops planted in the fields. They will not contain standing water long enough to cause damage to the crop plantings. The Basin 4 outlet tile's path from the basin down to the bottom of the ravine is steep and now contains loose, non-compacted soil due to the tile's burial, so in addition to its' being seeded, it was covered with a 3 inch layer of straw mulch to protect it from erosion until it vegetates. See Figure 15.

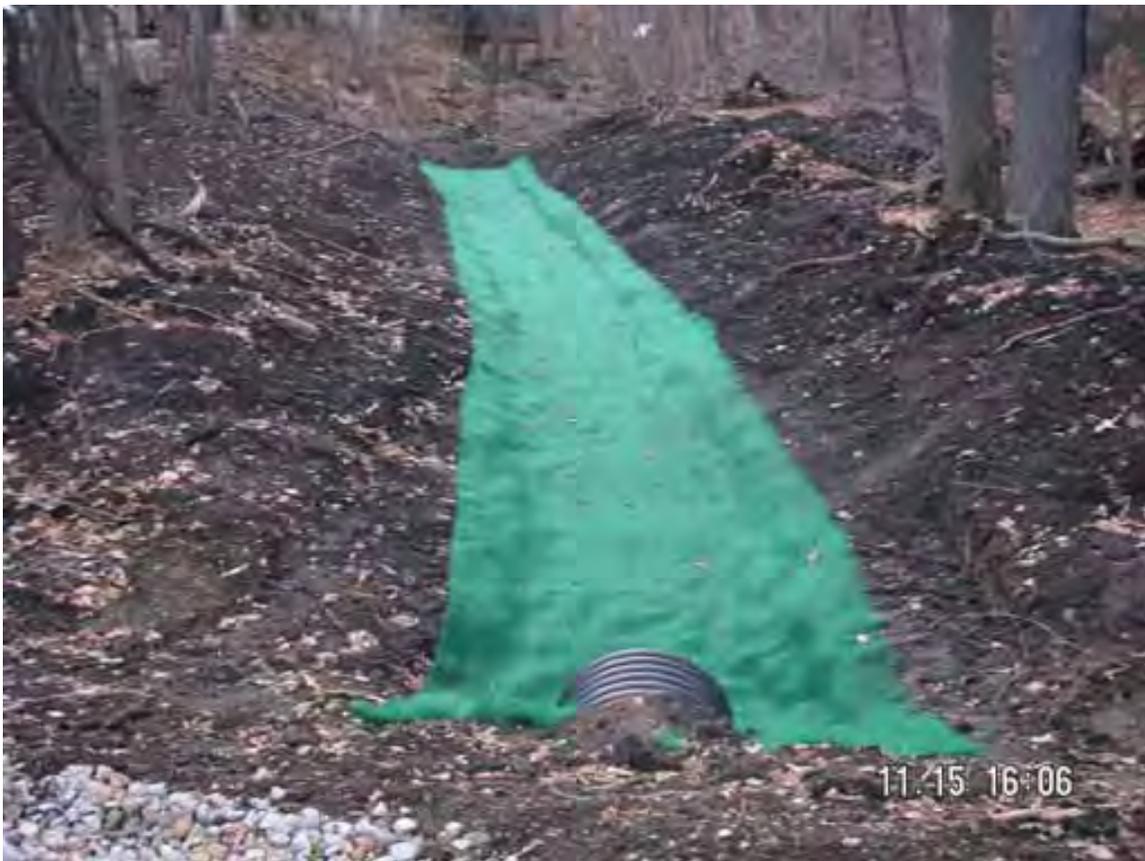
Figure 16. - Culvert Inlet, Looking West

The water that enters the Cyrus Trail Ravine then travels along the channel at the bottom of the ravine, east, toward Cyrus Trail. Originally, before the channel reached the road however, it turned right (south), passed under one driveway and then merged with the road drainage ditch, ran through the ditch for about 350 feet, then turned left and passed under the road and through another ditch traveling east, and emptied into Wolf Creek. If the drainage system used this path to the lake, the county and the MPCA would object, because this would constitute a “direct discharge” into a public waterway, which is no longer permitted. That is because the water will still contain a small amount of silt and a significant amount of nutrients – bad for the lakes and rivers. So a second feature was added to the drainage system. The ravine’s channel was changed to flow under the road where it originally turned right instead of merging with the road ditch. A new culvert was installed under the road, which outlets into a small DNR-owned parcel between the road and the lake, at the mouth of the Wolf Creek Inlet. That parcel contains a small wetland. The MPCA considers a drainage discharge into a wetland to be an ideal solution, because wetlands filter the remaining silt out of the water and also absorb the nutrient chemicals before they reach the lake. The DNR allows the county to manage its lakeshore lands and the county gave their permission for this outlet location. Figures 16 through 19 show the road culvert’s inlet and outlet and the redirected path of the ravine channel.

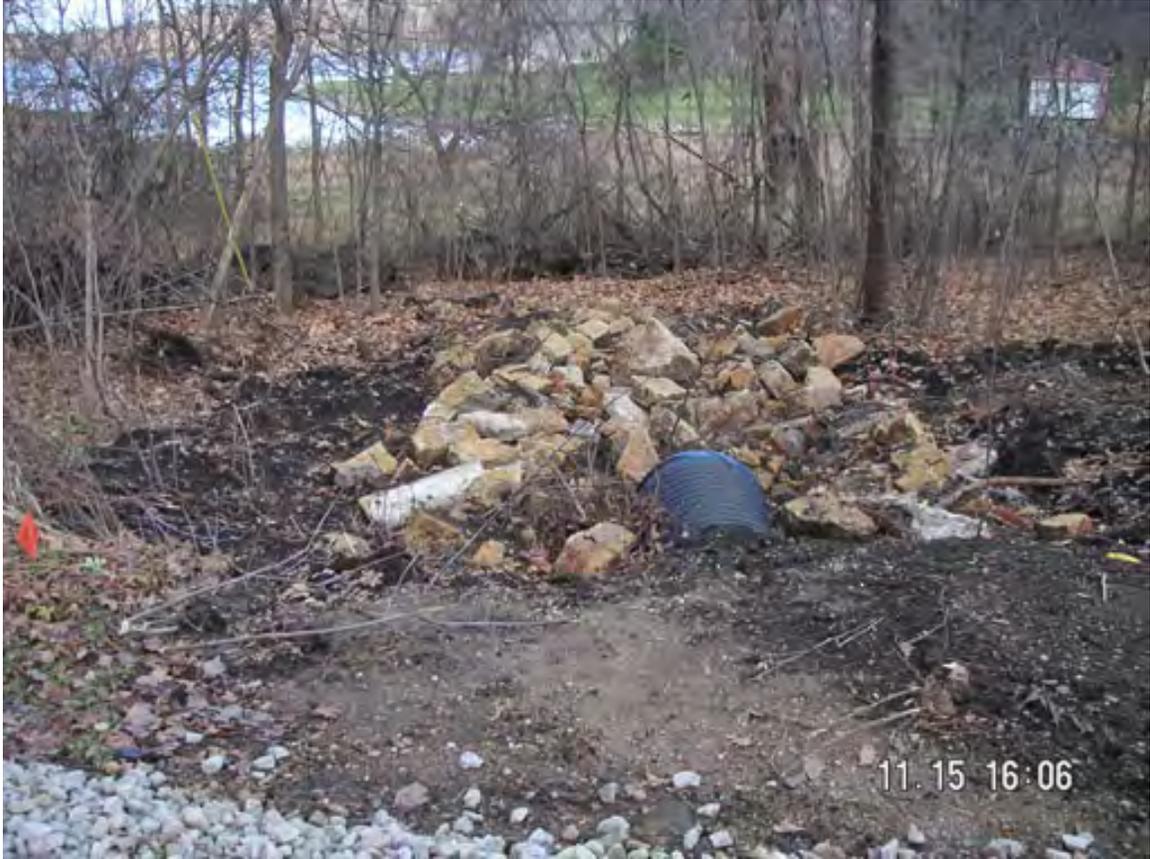
Figure 17. - Culvert Outlet, Looking East, Showing Wetland and Creek Mouth

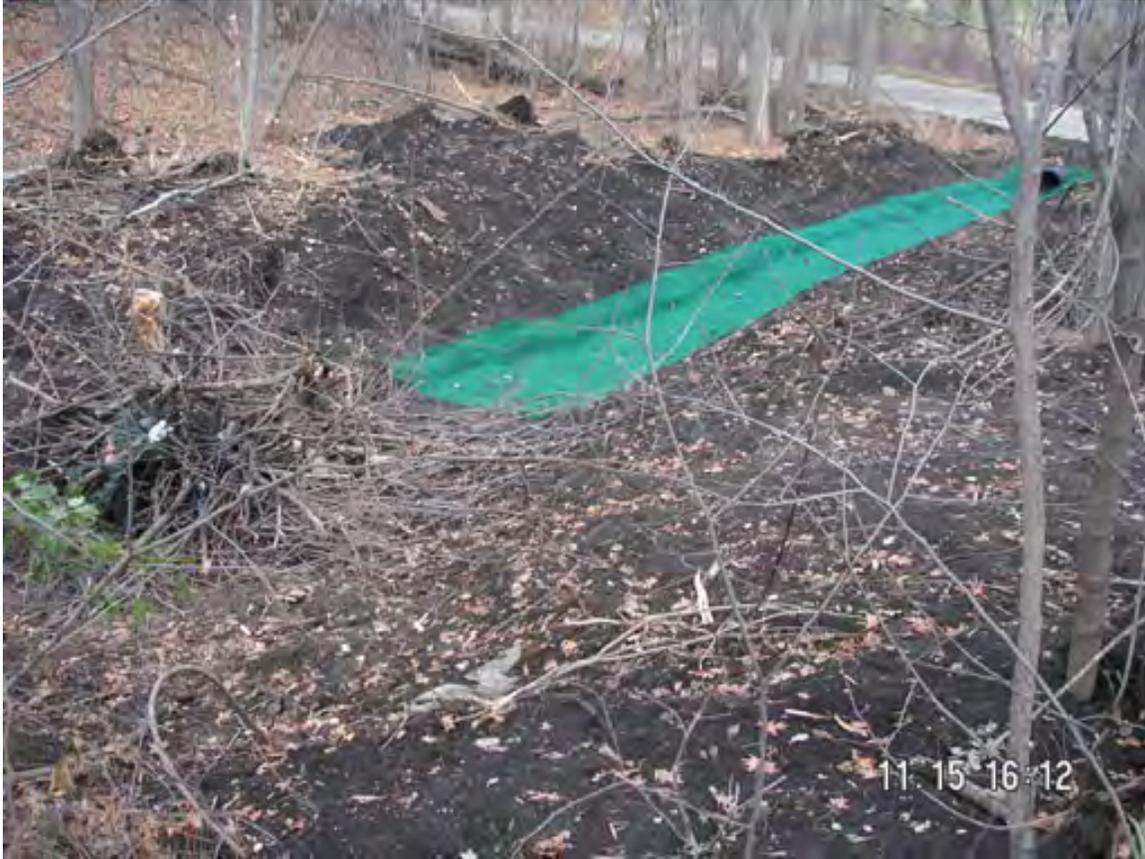
Figure 18. - Redirected Channel Path, Looking Northeast

The green material shown in the figures is a permanent erosion control fabric. In Figure 18, the original channel path passed to the right. It has been filled in to block the path through the driveway culvert (not shown) and into the road ditch.
