Circle Lake Report

Rice County, MINNESOTA

Summary of the Lake Management Study

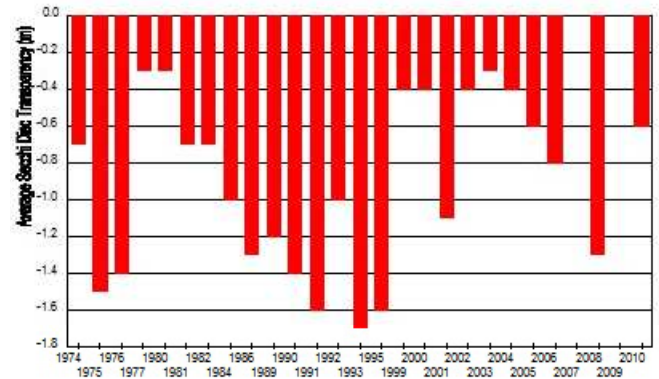
Summer average water clarity measurements based on Secchi disc measurements for Circle Lake.

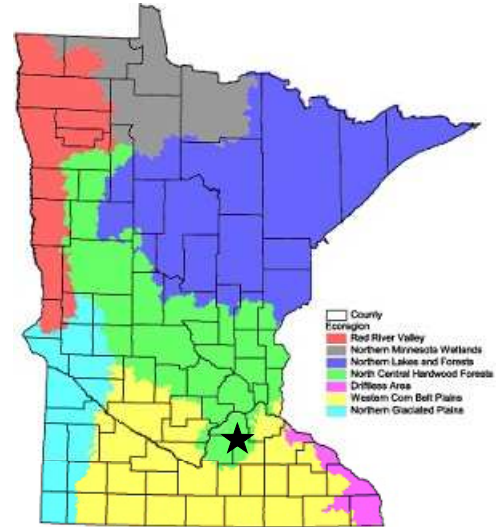
Circle Lake is located in the North Central Hardwood Forest Ecoregion. Lakes in this ecoerigion have water clarity between 5 - 8 feet.

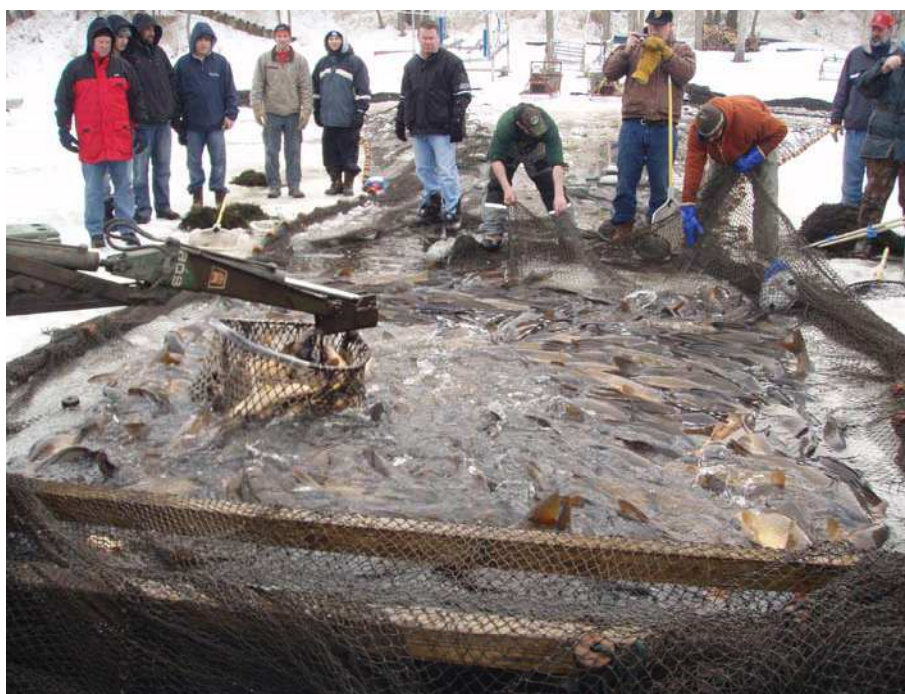
Example of a carp harvesting operation.

2. Fish Management		
2-1. Carp management	5 years @ \$30,000/yr = \$150,000	Commercial fishermen
2-2. Winter aeration	\$1,000 per year (electrical plus maintenance)	Circle Lake Association
