## Ravine Project SW corner of Circle Lake

Numerous ravines enter Circle Lake. During a moderate to heavy rain event, the water rushing down the ravines transports large amounts of sediment into the lake. Below are pictures of what was occurring in one ravine on the southwest corner of the lake.

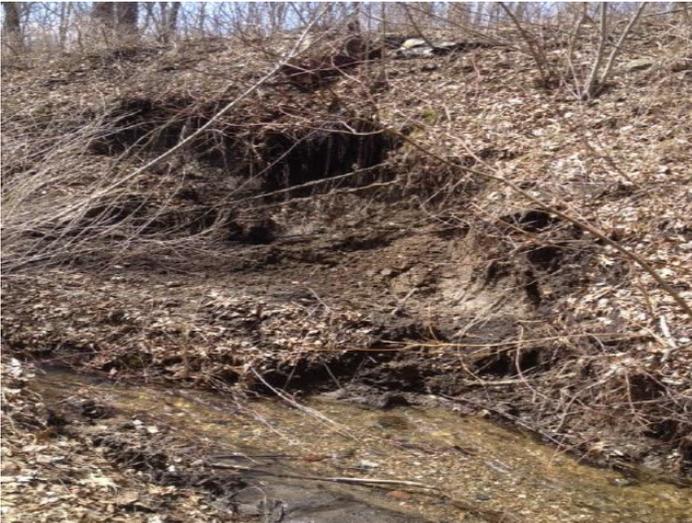
A chunk of dirt the size of a full size car caving in from the side wall and falling into the ravine where water can readily carry it into Circle Lake. April 2014.

The solution to the above problem was to slow the water's down to reduce the amount of soil undercut from the sides of the ravine. To do this, a concrete berm and a series of log cribs were constructed in the ravine. Combined with the use of on-site brushy materials, these structures have succeeded in slowing the speed of the water, and significantly reduced the amount of sediment entering Circle Lake from this point source. In spite of extremely difficult working conditions, (it was a very wet June) our contractor, Sonnee Environmental Services, completed the project on schedule. Funding for this engineered project came from the Circle Lake Association, the Tri-Lakes Sportsmen's Club, and the landowners.

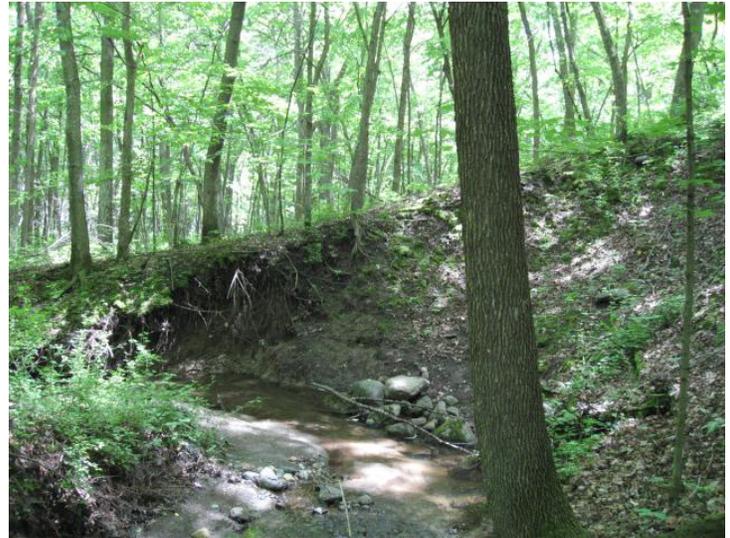
A sharp curve in the ravine. Water undercutting the embankment prior to erosion control structure installation. Late May 2014.

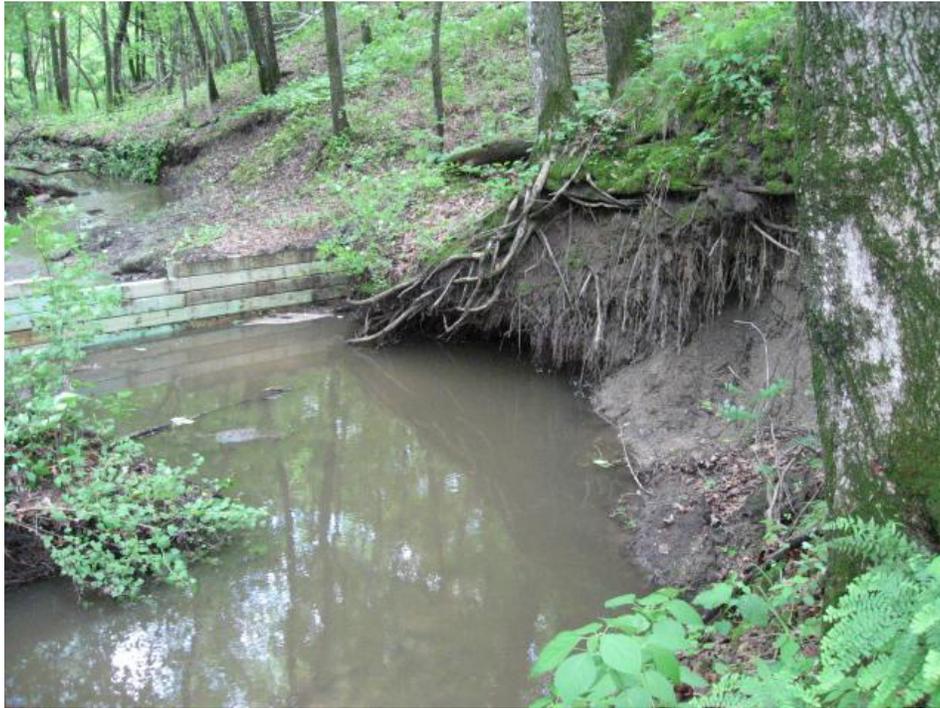
A sharp curve now with log crib structure installed. Water pools up in front of the structure and no longer achieves sufficient energy to undercut the bank. June 2014.

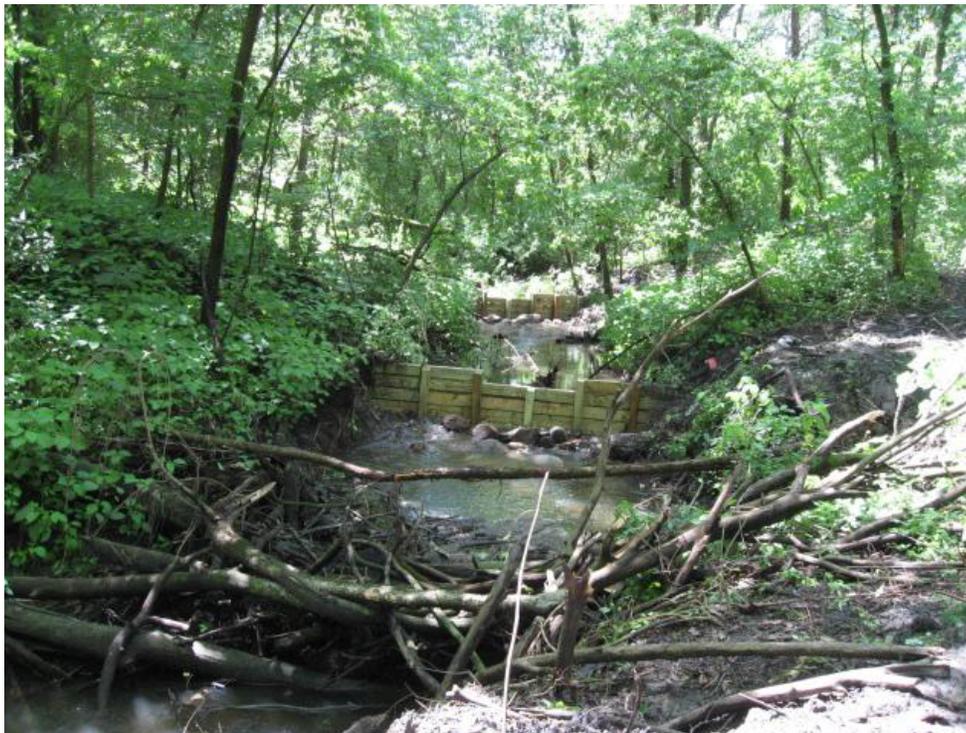
An example of how the structures were installed in a sequential series to prevent water from gaining sufficient momentum to cause significant erosion. Also, on site brushy material used for additional erosion control assistance. June 2014.

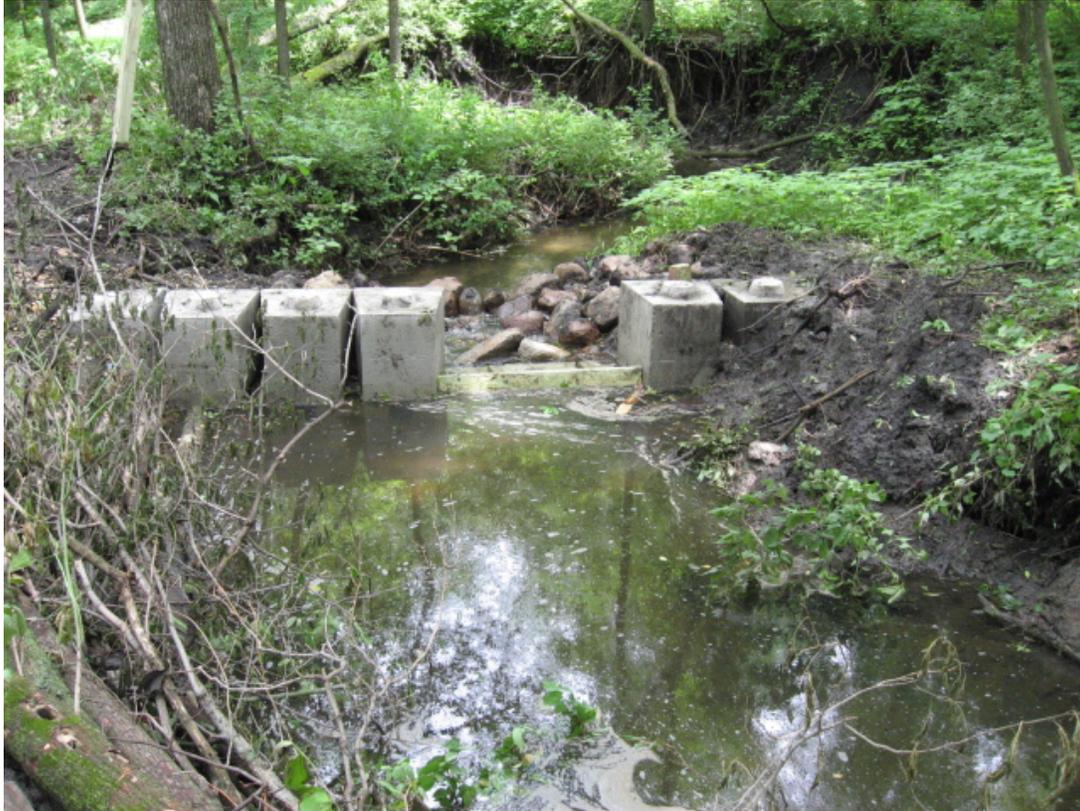
Water pools in front of the one concrete structure in this project. The open area between the concrete blocks is to allow the water to move more quickly through this structure during high flow. This keeps the structure from being over topped.

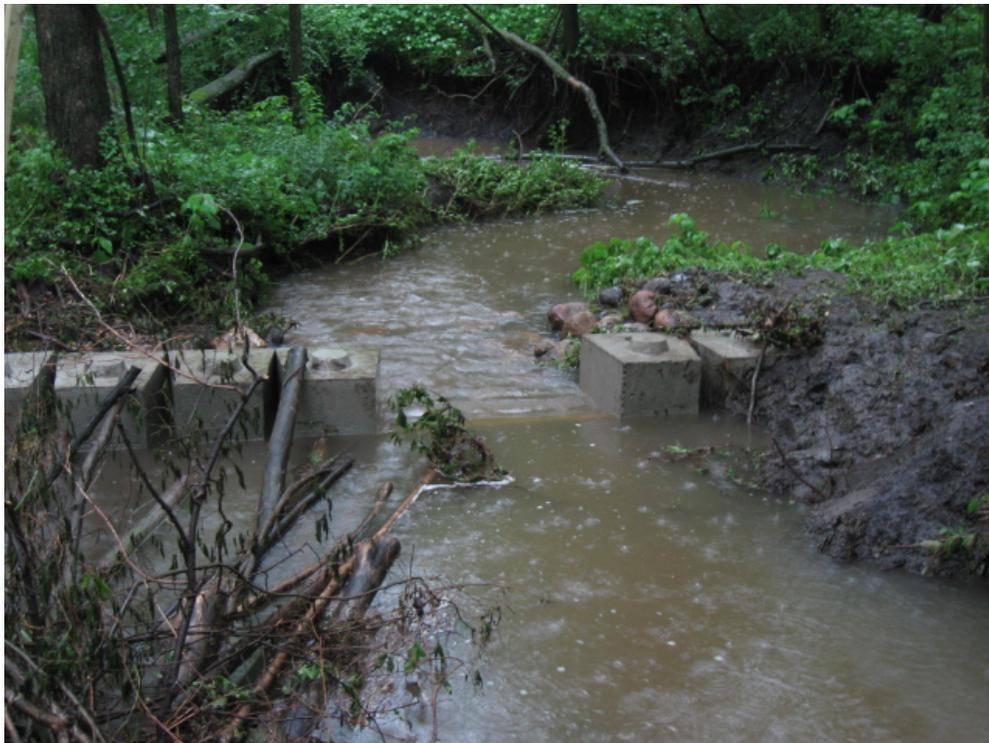
The concrete structure during a high water event.
